MOLD INSPECTION AND TESTING REPORT CIRS PROTOCOL

CLIENT	John Bluecheese
PROPERTY ADDRESS	2523 Laboratory Dr ~ Suspect, Colorado 80555
DATE OF INSPECTION	Tuesday, October 13, 2021

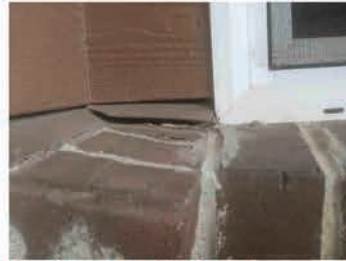
EXTERIOR [WEST]

Openings/cracks in exterior walls were observed.

Area Affected: 3 Sq In

Suspected source(s)/cause(s):
Openings / cracks

Openings and cracks observed.

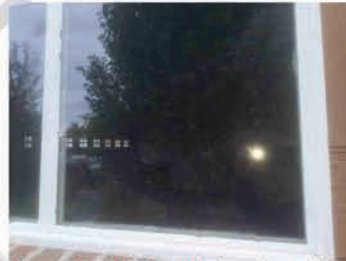
EXTERIOR [SOUTH]

Cracked window was observed.

Cracked and broken window observed common Garage.

Area Affected: 2 Lineal Ft

Suspected source(s)/cause(s):
Cracked window

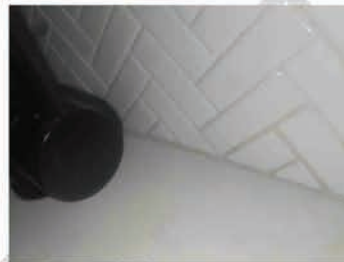
KITCHEN [NORTH]

Caulking around toilet and/or sink is in poor condition.

Moisture Content: Dry
Humidity this area: 56%
Humidity Outdoor: 65%
Area Affected: 2 Lineal Ft
Suspected source(s)/cause(s):
Cracked / deteriorated caulking

Cracked and deteriorated caulking observed around sink.

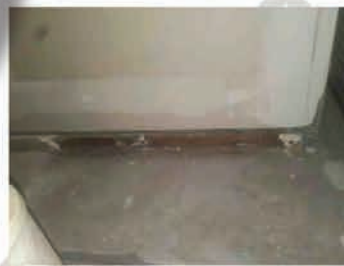
BASEMENT [WEST]

Water staining and damage observed on drywall and sill plate.

Moisture Content: Dry
Humidity this area: 47%
Humidity Outdoor: 65%
Area Affected: 6 Lineal Ft
Suspected source(s)/cause(s):
Previous HVAC / water heater plumbing leak

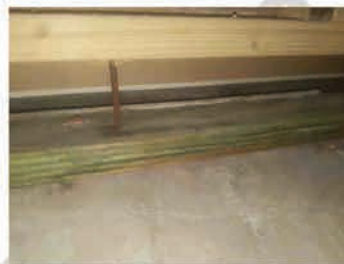
UTILITY CLOSET [EAST]

Water damage - Moisture damage or staining observed in this area.

Moisture Content: Dry
Humidity this area: 54%
Humidity Outdoor: 65%
Area Affected: 6 Lineal Ft
Suspected source(s)/cause(s):
Previous HVAC / water heater plumbing leak

Water staining and damage observed on sill plate.

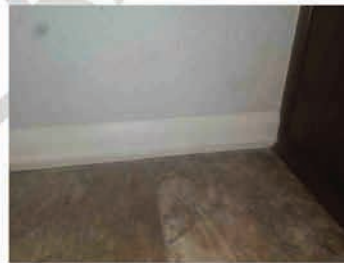
HALL BATHROOM [EAST]

Water damage - Moisture damage or staining observed in this area.

Suspected source(s)/cause(s):
Incidental moisture from shower and/or previous toilet plumbing leak and/or previous Laundry Room plumbing leak

Water staining and damage observed on baseboards around shower and toilet plumbing.

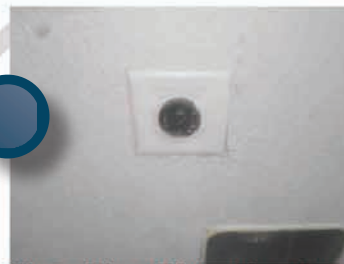
LAUNDRY ROOM [EAST]

Water damage - Moisture damage or staining observed in this area.

Suspected source(s)/cause(s):
Previous roof leak and/or previous laundry plumbing leak and/or previous Hall Bathroom plumbing leak

Water staining and damage observed on ceiling and wall common Hall Bathroom.

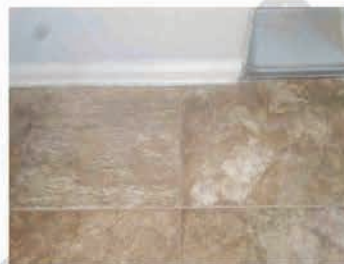
LAUNDRY ROOM [EAST]

Water damage - Moisture damage or staining observed in this area.

Water staining and damage observed on baseboard and flooring.

Suspected source(s)/cause(s):
Previous roof leak and/or previous laundry plumbing leak and/or previous Hall Bathroom plumbing leak

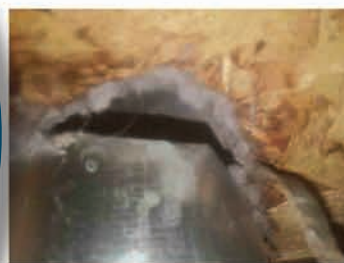
ATTIC [WEST]

Water damage - Moisture damage or staining observed in this area.

Suspected source(s)/cause(s):
Previous leak at roof

* Humidity level for this area is above the ASHRAE recommended level for habitable spaces. Preferable level is between 30% and 60%.

Water staining and damage observed on sheathing around Hall Bathroom vent termination.
